IMPACTS OF FLOW AUGMENTATION ON RIVER CHANNEL PROCESSES
AND RIPARIAN VEGETATION

A Thesis
Submitted to the School of Graduate Studies
of the University of Lethbridge
in Partial Fulfillment of the
Requirements for the Degree

Department of Biological Sciences
University of Lethbridge
LETHBRIDGE, ALBERTA, CANADA

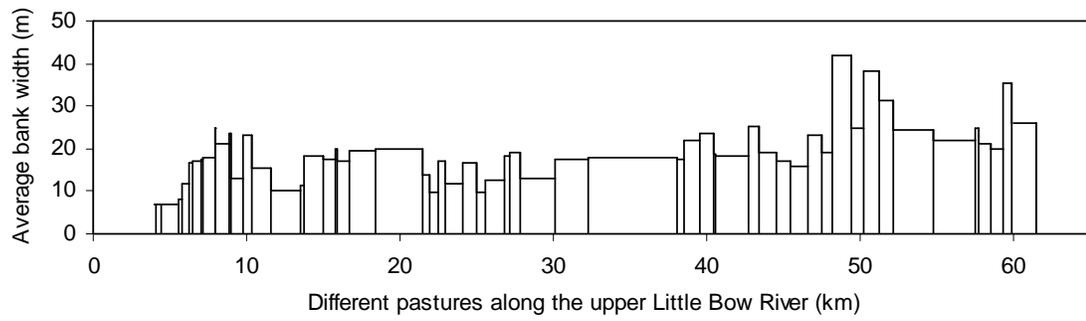
Figure 2-11 Average channel width calculated for different fenced parcels of land along the upper Little Bow River.

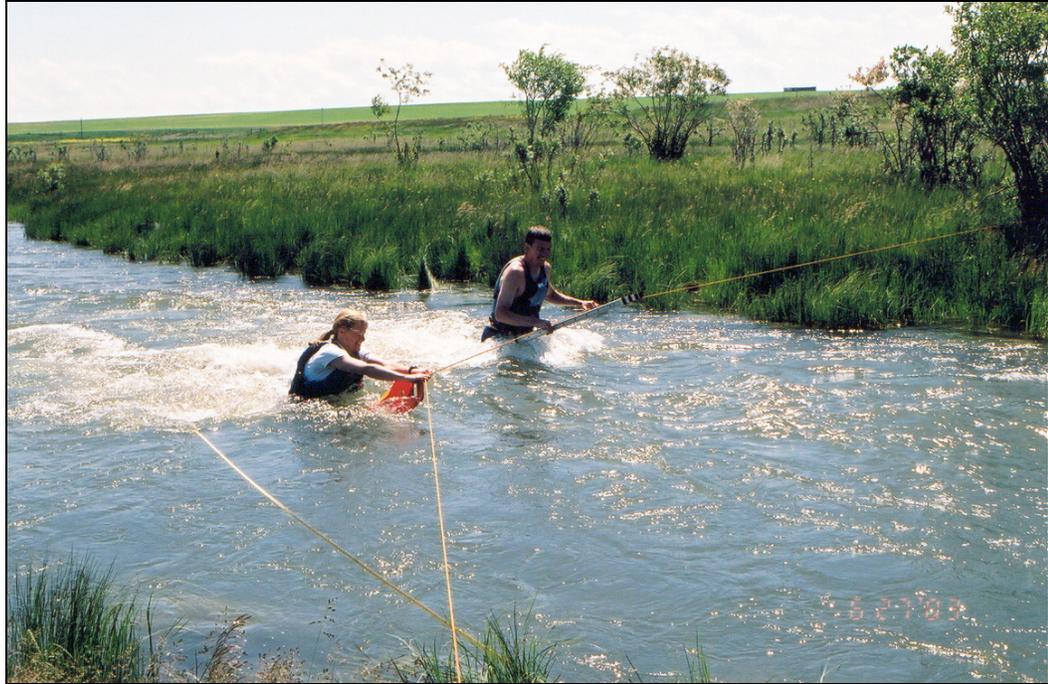
Figure 3-18 Increased velocities with increased flow on June 27th, 2003 at distance of 8.2 km along the upper Little Bow River ($Q_d = 8.05 \text{ m}^3/\text{s}$) (S. Rood).

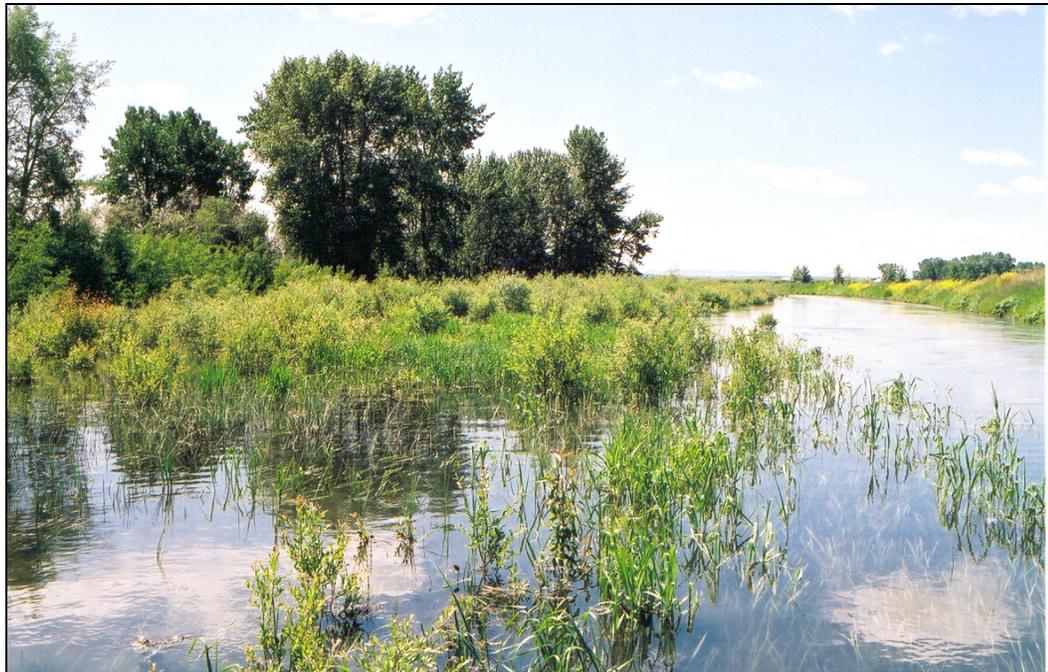
Figure 3-19 Inundation of the flood tolerant willow zone caused by increased flows on June 27th, 2003 at a distance of 4.75 km along the upper Little Bow River ($Q_d = 8.05 \text{ m}^3/\text{s}$) (S. Rood).

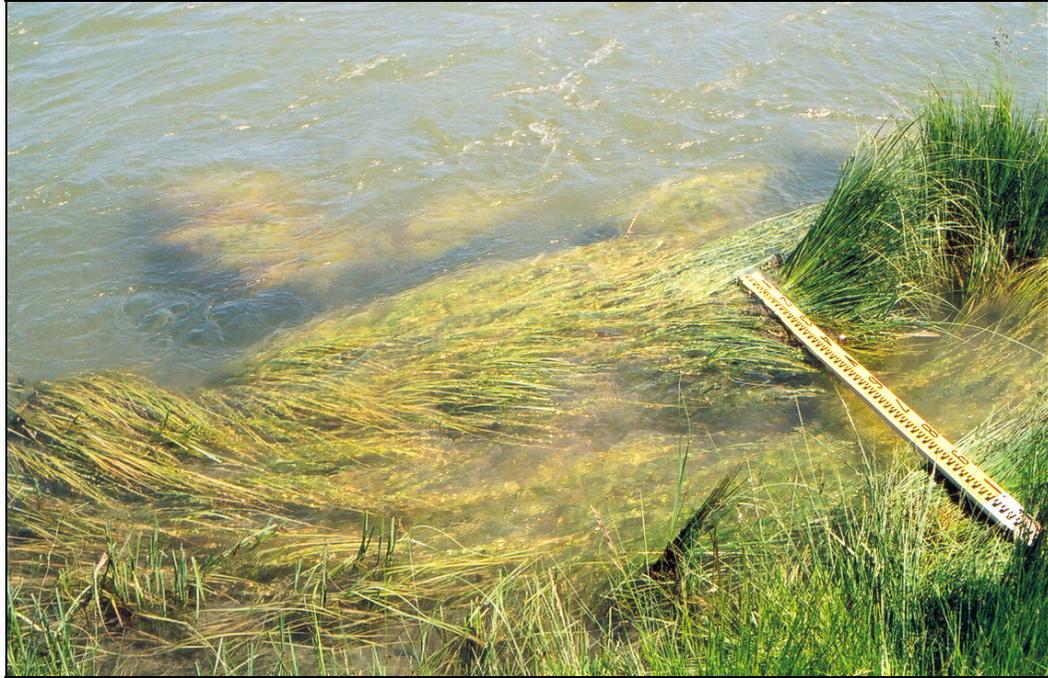
Figure 3-20 Localized clump-erosion caused by increased flows on June 27th, 2003 at a distance of 8.2 km along the upper Little Bow River ($Q_d = 8.05 \text{ m}^3/\text{s}$) (S. Rood).

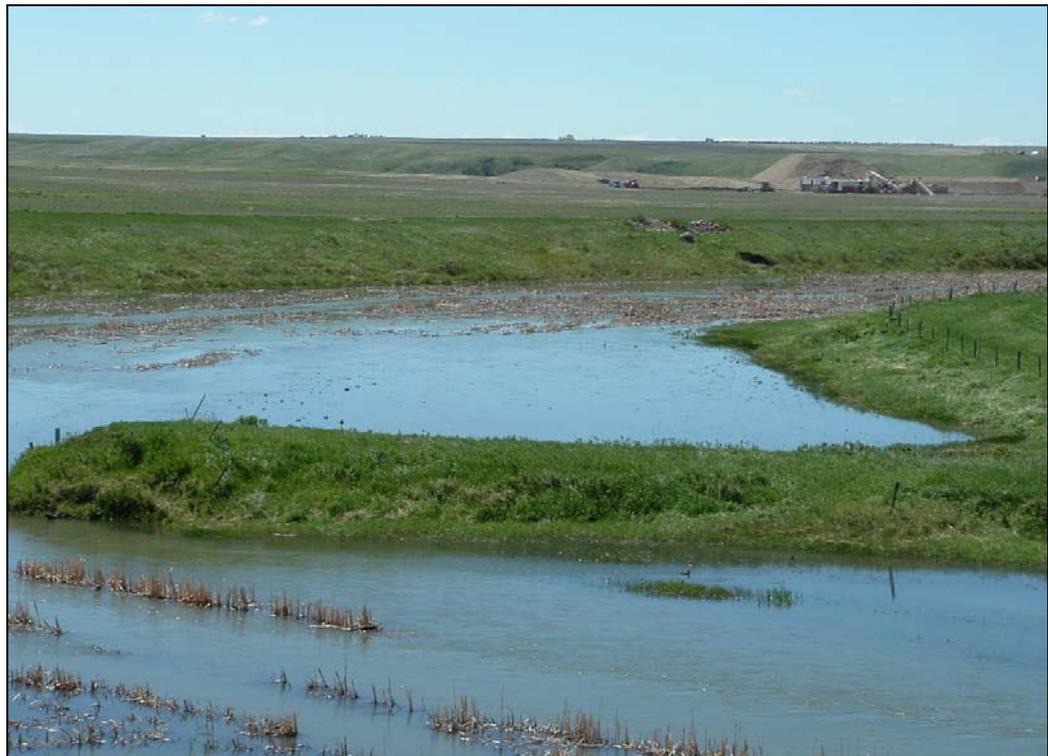
Figure 3-21 Inundated cattails on May 25th, 2004 at a distance of 55.15 km along the upper Little Bow River ($Q_d = 4.65 \text{ m}^3/\text{s}$) (S. Bigelow).

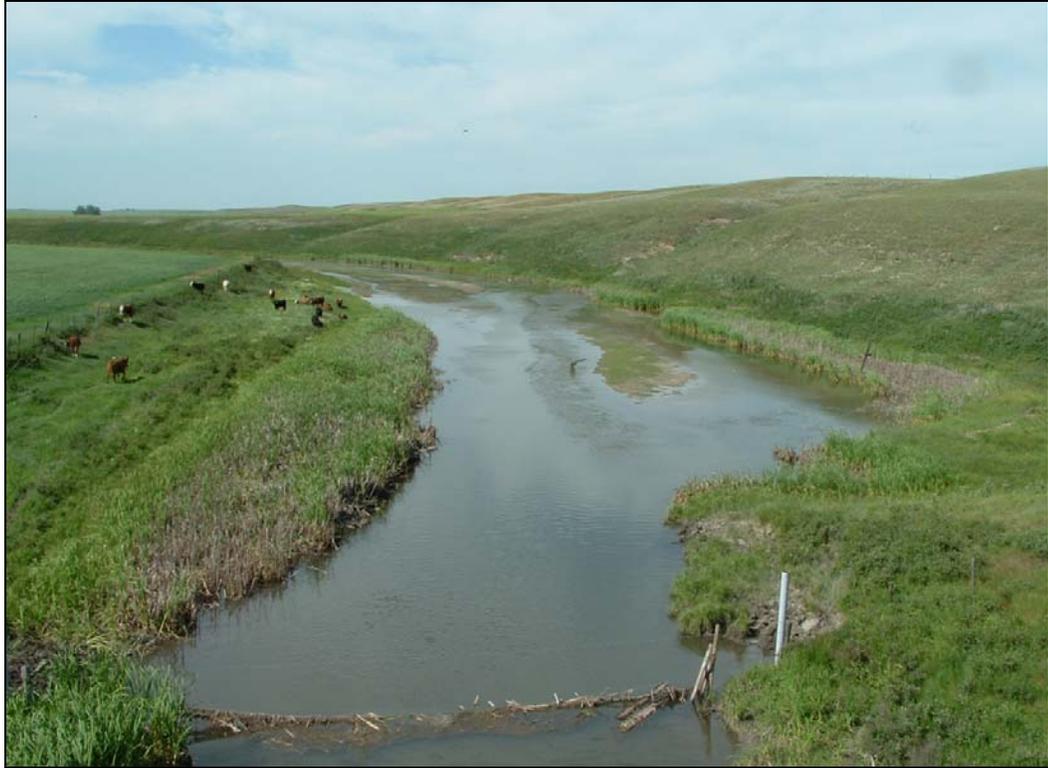
Figure 3-22 Livestock grazing and deposition on July 16th, 2004 at a distance of 54.8 km along the upper Little Bow River ($Q_d = 3.8 \text{ m}^3/\text{s}$) (S. Bigelow).

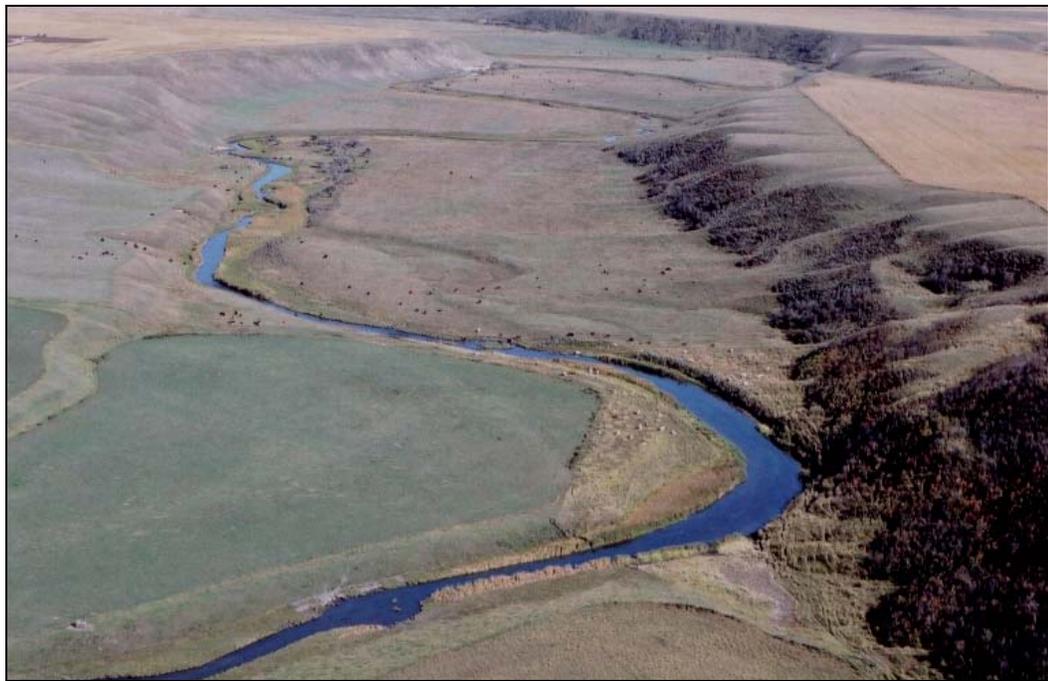
Figure 3-23 The Little Bow Valley extending from 32 to 35.5 km along the upper Little Bow River on September 21st, 2004 ($Q_d = 0.67 \text{ m}^3/\text{s}$) (S. Rood).

within the riparian zone. Figure 3-23 (at 32 km to 35.5 km) was taken from a low flying aircraft in September of 2004 and illustrates the middle portion of the study reach. Many attributes of the valley and channel can be recognized, especially a grass dominated landscape for a Bebb willow community along side the river. Extensive livestock grazing was also common throughout segments of the study reach.

The presence of livestock grazing along the upper LBR was captured in various photos (Figure 3-22 at 54.8 km and Figure 3-23 at 32 to 35.5 km). Grazing can cause the breakdown of stream banks and increased erosion from trampling that reduces bank stability and resistance (Belsky et al. 1999), as well as increase sediment deposition and inhibit growth and survival of deep-rooted plants that anchor and stabilize channel banks.

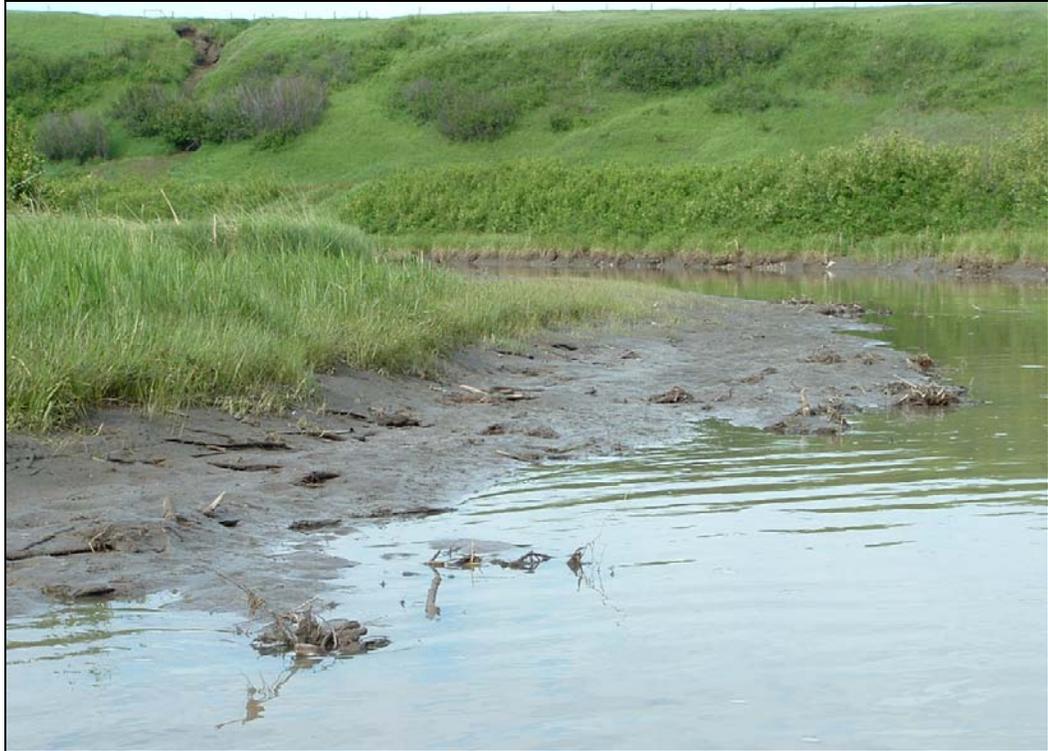
Figure 3-24 Deposition and debris on June 11th, 2005 at a distance of 17.8 km along the upper Little Bow River ($Q_d = \text{unknown}$) (S. Bigelow).

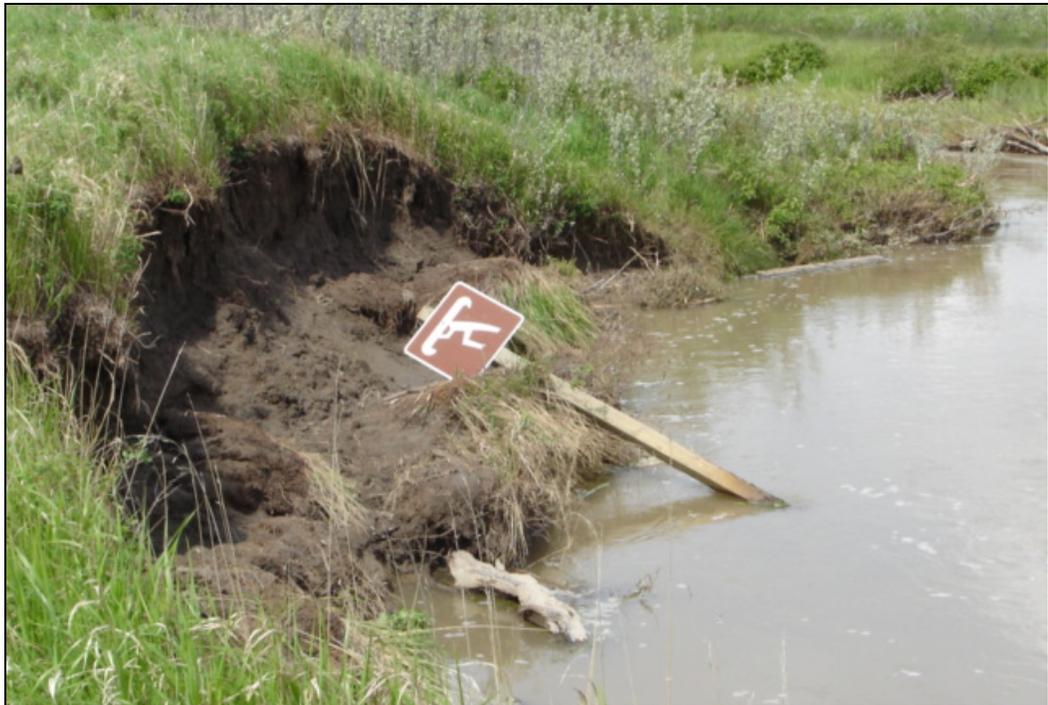
Figure 3-25 Bank slumping on June 11th, 2005 at a distance of 20.75 km along the upper Little Bow River ($Q_d = \text{unknown}$) (S. Bigelow).

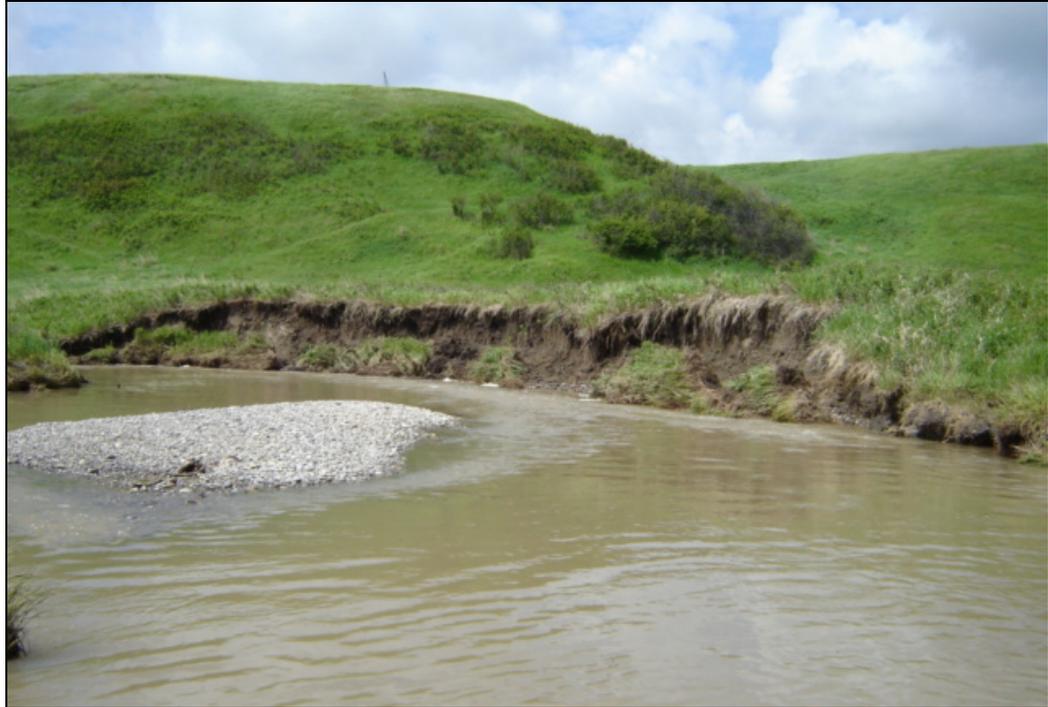
Figure 3-26 Localized bank slumping and deposition of a gravel bar on June 11th, 2005 at a distance of 20.95 km along the upper Little Bow River (Q_d = unknown) (S. Bigelow).

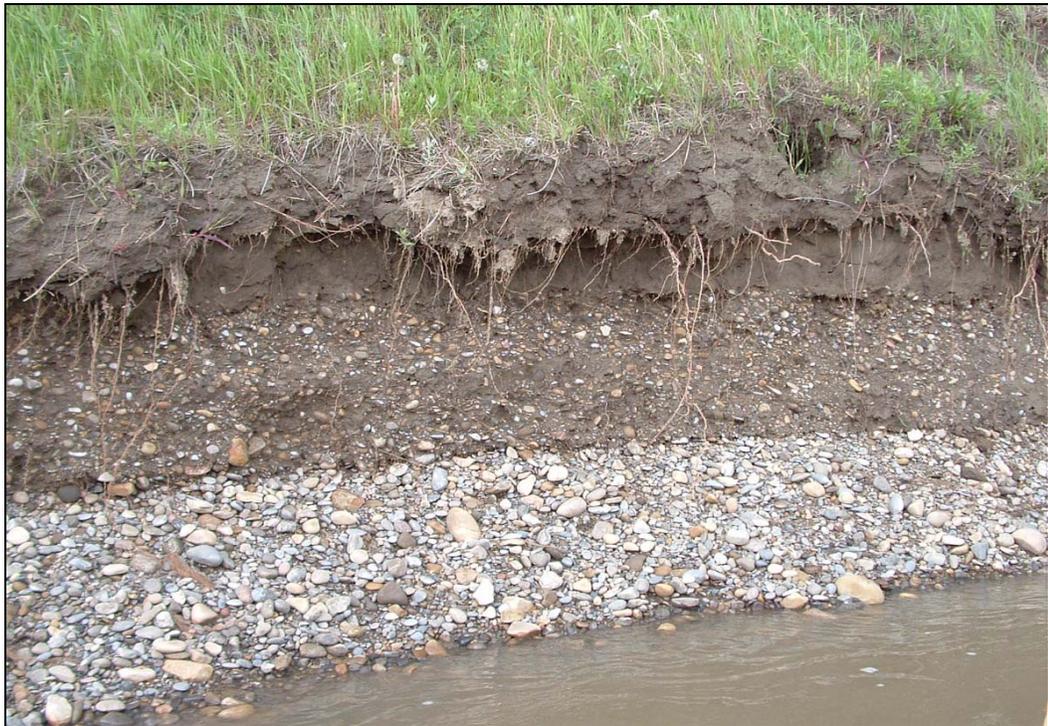
Figure 3-27 Exposed stratified sediment layers along a concave cut-bank on June 11th, 2005 at 27.6 km along the upper Little Bow River (Q_d = unknown) (S. Bigelow).

For June of 2005 there was heavy rain within the region. Photos taken along a float on June 11th and 12th, 2005 revealed localized zones of major bank erosion and deposition. The discharge was unknown during this period due to flooding of the gauge along Little Bow Canal. Figure 3-24 (17.8 km) illustrates deposition of fine sediment and cattail debris along a point bar. Channel impacts included major bank slumping along concave banks (Figure 3-25 at 20.75 km) and further downstream, gravel bar deposition occurred. This observation was more common in areas dominated by grass (Figure 3-26 at 20.95 km). Recent erosion of concave banks revealed bank composition and formation, demonstrating the layered accumulation of gravels and finer sediments (Figure 3-27 at 27.6 km).
