RIVER AND RIPARIAN DYNAMICS AND
BLACK COTTONWOODS
IN THE KOOTENAY RIVER BASIN,
BRITISH COLUMBIA AND MONTANA

A Thesis Submitted to the Council of Graduate Studies of the University of
Lethbridge in Partial Fulfillment of the Requirements for the Degree
MASTER OF SCIENCE

LETHBRIDGE, ALBERTA
August, 1998

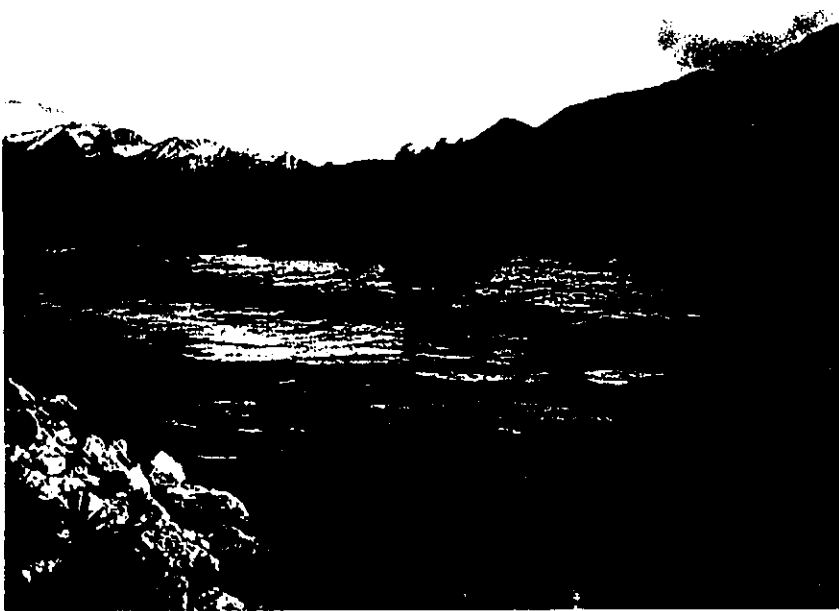
Figure 8. Site 1 at $49^{\circ} 25' \text{ N } 115^{\circ} 02' \text{ W}$ along the Elk River, (a) June 7, 1995, (b) early July 1995, (c) and Aug 3, 1996.

Site 1 was revisited in July, 1995 and the submerged island in Figure 8a is shown in Figure 8b. The waters had receded but were still above average stage and were still murky. The discharge of the Elk River on July 5, 1995 was 166 m³/s and the range for the month of July was 166 to 62 m³/s (July 31). The same month in 1994 had a peak of 82.7 m³/s on the first of July and declined to 38.9 m³/s by July 31. By autumn, the Elk River had deposited considerable sediment and the island at Site 1 had a larger bar on the inside than shown in the photo (Figure 8b).

Following the 1996 spring peak which was a 1-in 4 year flood event (Figure 7a), the island at Site 1 had been linked to the river bank (Figure 8c).

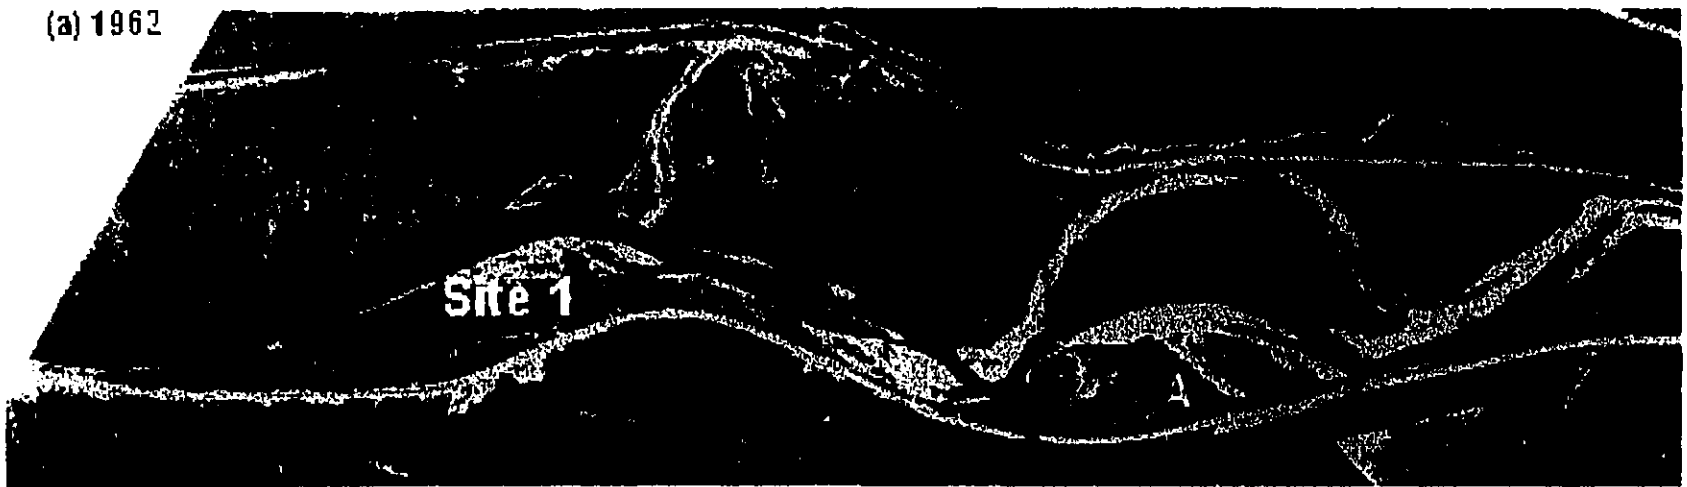
(a) 1962

Figure 11. The Elk River, (a) image taken Aug. 10, 1994 air-photo 30BCC94124:155 prior to the channel change, scale 1:15,000.
 (b) The approximate new coarse of the Elk River (overlay) in 1996, the base image is a portion of the (a) 1994 air-photo
 at a scale of approximately 1:10,700.

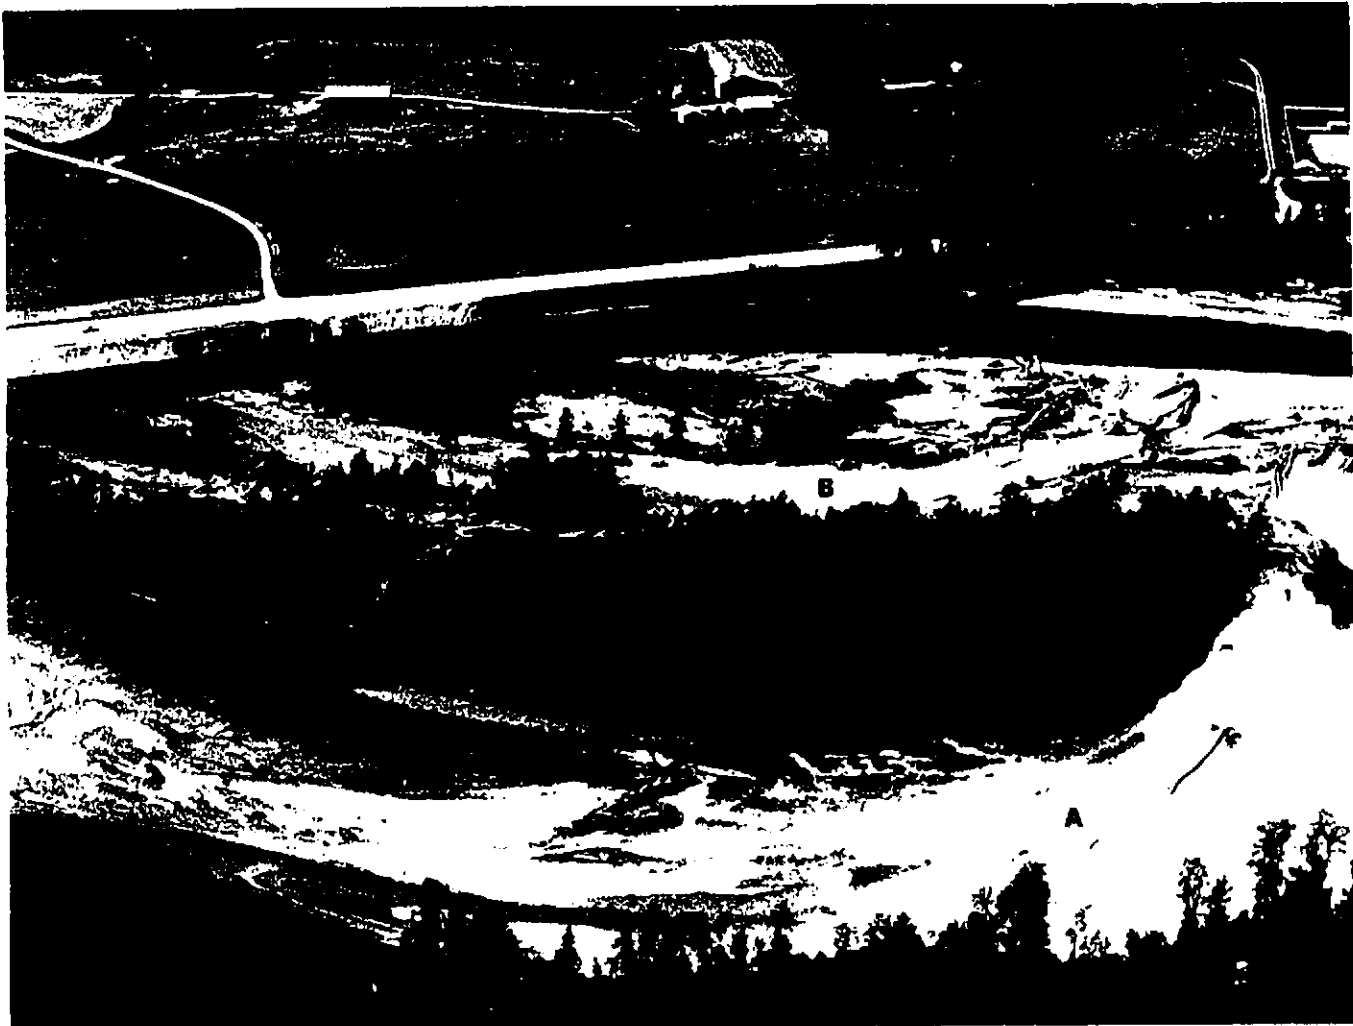
A – Old channel B – Old secondary channel C – New channel arrow – flow direction

Figure 10. The first site where the Elk River changed course, about 2 km downstream from Site 1 ($49^{\circ} 25' \text{ N } 115^{\circ} 02' \text{ W}$), in 1996. The main and secondary channels (A&B) were abandoned for the new channel (C) in 1996. Image recorded Aug. 3, 1996.

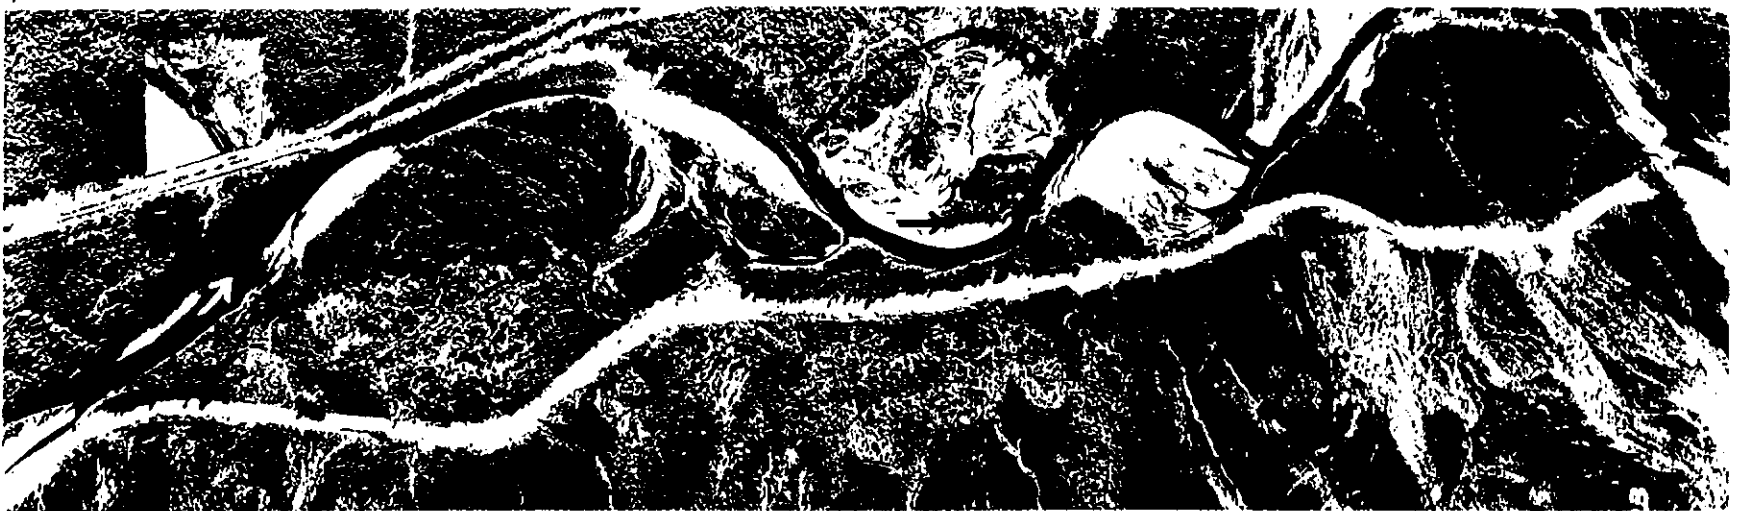
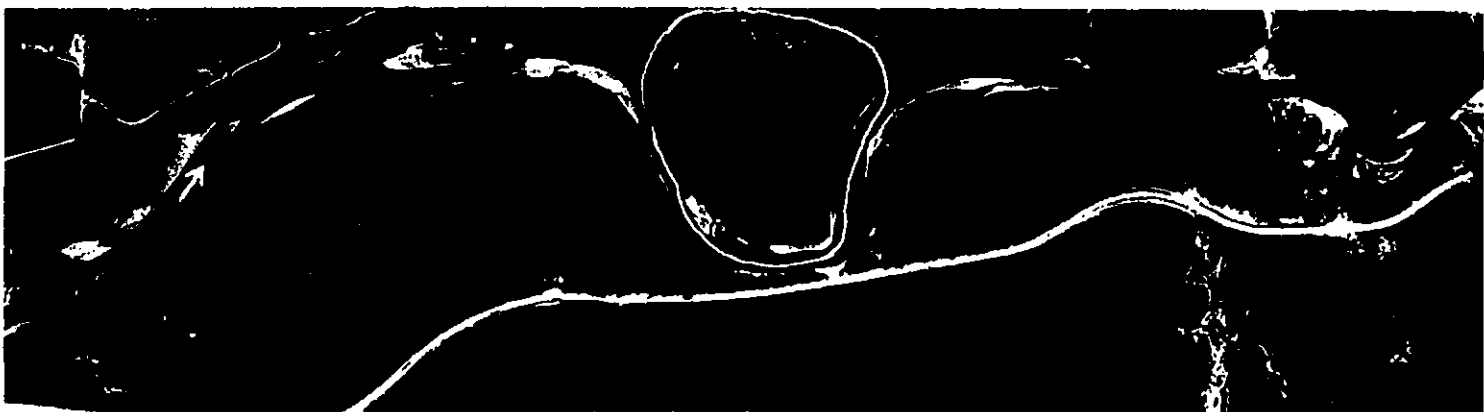
Figure 12. The circled site (a) and (b) was the second site of a channel change downstream from Site 3 ($49^{\circ} 21' N$ $115^{\circ} 00' W$). Images are from (a) air photo BC4057:103 July 9, 1962, and (b) air photo 30BCC94125:059 taken Aug. 10, 1994, both approximately 1:15,000 scale.

By 1994, most of the meander lobe had been colonized by cottonwoodlands, but a grassy channel could still be seen running along the back of the meander lobe (Figure 12b). Water follows the path of least resistance, and subsequently the 1995 flood scoured this path of grasses, enlarging it by removing cottonwoods along its edges (Figure 13). The new

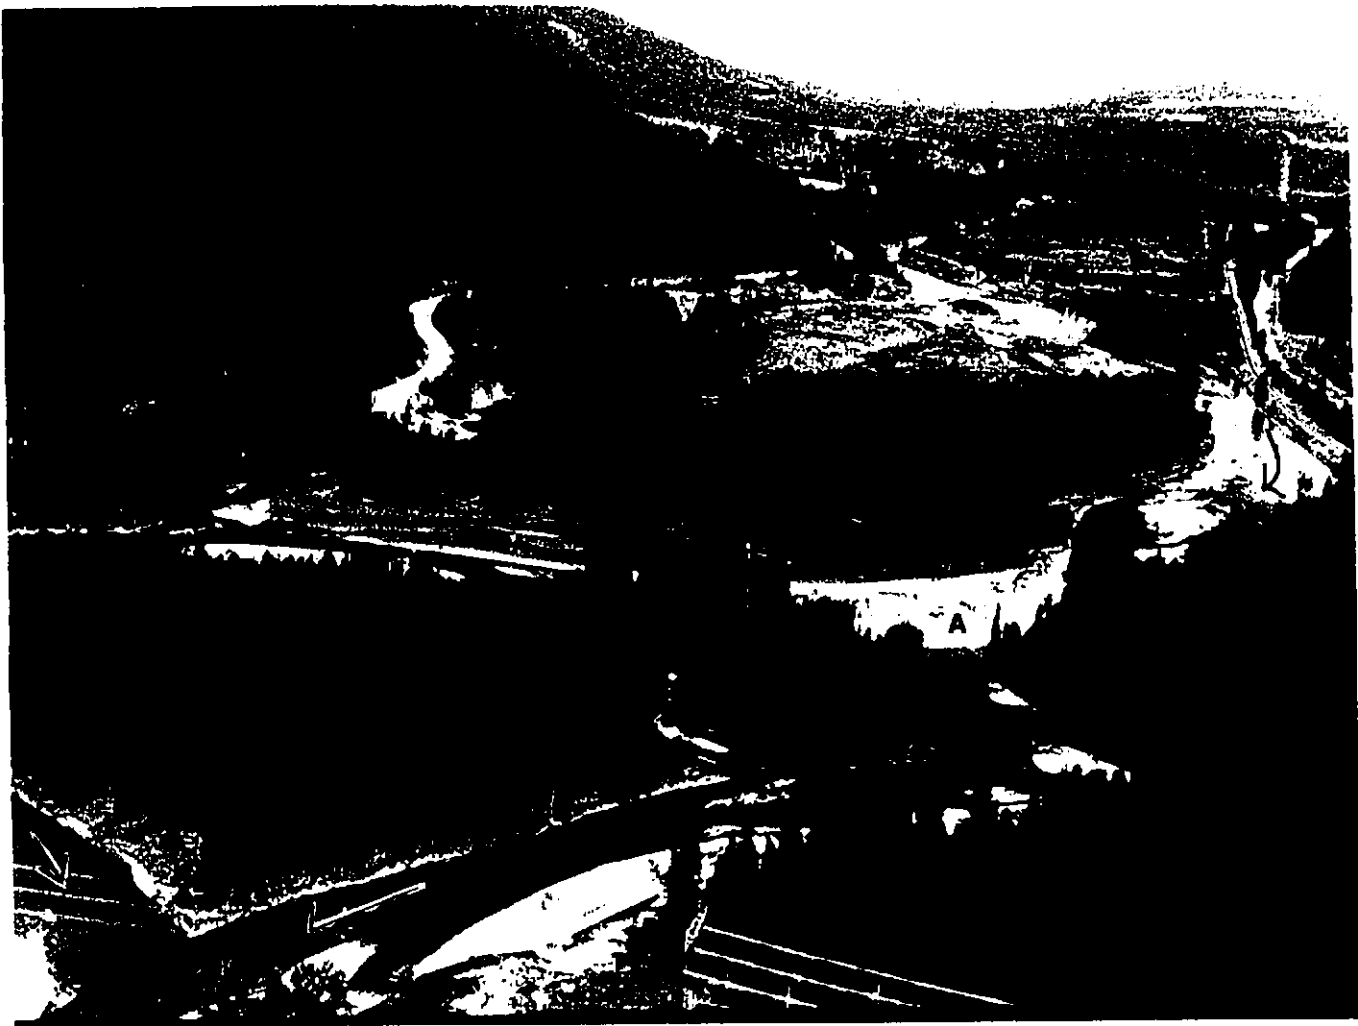
A – Site 3 B – New channel C – Original channel

Figure 13. The site of the second channel change adjacent to Site 3 ($49^{\circ} 21' \text{ N } 115^{\circ} 00' \text{ W}$) along the Elk River Aug. 3, 1996.

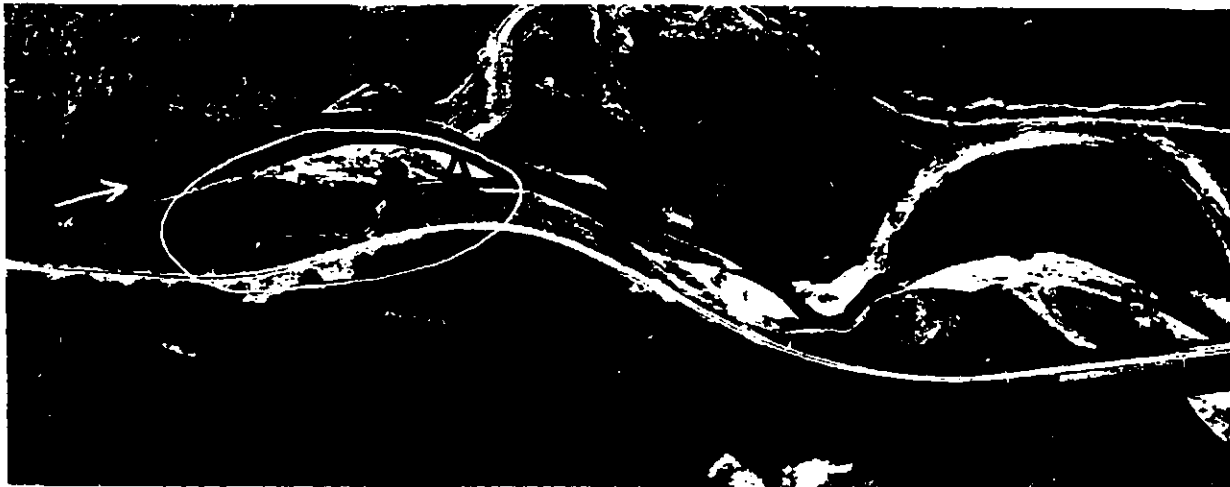
Figure 15. Elk River channel migration and formation of islands (A and B) from 1962 to 1994 at $49^{\circ} 25' N$ $115^{\circ} 02' W$. Site 1 is circled and images are a scale ranging approximately 1:15,000 to 1:20,000.

Site 1 with transect line 0637, underwent noticeable geomorphological change in recent decades. Figure 15a shows the area (circled) in 1962. At that time, the site was on a meander lobe with considerable cottonwood recruitment sites apparently available. In 1981, the meander lobe had a section cut off from it forming part of a new island, and the river had eroded the opposite bank, shifting the river left (facing downstream) to accommodate the island (Figure 15b). By 1994, the island had cottonwood recruitment and had grown in size through deposition (Figure 15c). The continued erosion of the left bank increased the width of the river channel on the left side of the island (Figure 16). After the 1995 flood, the right channel had been reduced but still flowed. Following the flood of 1995, and the high flow of 1996, the right channel of the island was closed off to reconnect the island with the meander lobe. A partial back channel resulted that was fed by a small creek and the Elk River (Figure 17a). After the 1997 peak, the downstream edge of the meander lobe had elongated and approached the mainland with only a slightly submerged bar prevented the final connection (Figure 17b). This demonstrates the extent of deposition and the downstream advance of the meander lobe during the two years after the 1995 'flood of the century'.

All of the trees sampled, on the old island, were 20 years old or younger (Table 3). This is supported by the 1981 air-photo (Figure 15b) which shows a barren site. Small seedlings would be too small to show up on such an air-photo, however the air-photo does show other vegetation, such as grasses, had not colonized the site by 1981. The trees on the island (Figure 24b) were tightly clumped suggesting that these groups were of clonal origin (Gom 1996). Because of this, only the largest tree of the group was cored to best estimate the age of the original tree

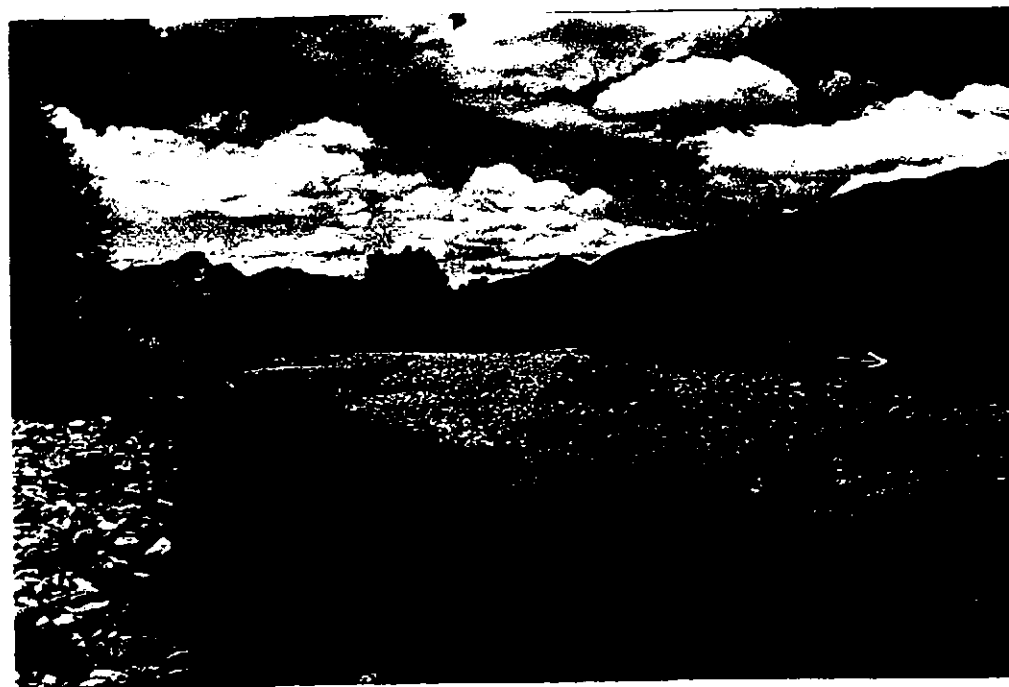
(b) 1997, A - bar

Figure 17. Elk River Site 1 ($49^{\circ} 25' \text{ N } 115^{\circ} 02' \text{ W}$), (a) oblique photo taken August 3, 1996 and (b) photo taken at ground level in 1997, extension of the bar.

The formation of the island (A) at Site 1 was not the only change which occurred along this stretch of the Elk River. Figure 16 shows the changes that occurred along this reach. These included the moving of Highway 3 as it was eroded away by the Elk River upstream of Site 1, the loss of three islands (marked 1, 2, 3) just downstream of the new island (A), and the formation of another new island (B). Figure 15b shows the start of island B in 1981 as a portion of the meander lobe which was latter cut off from the mainland.

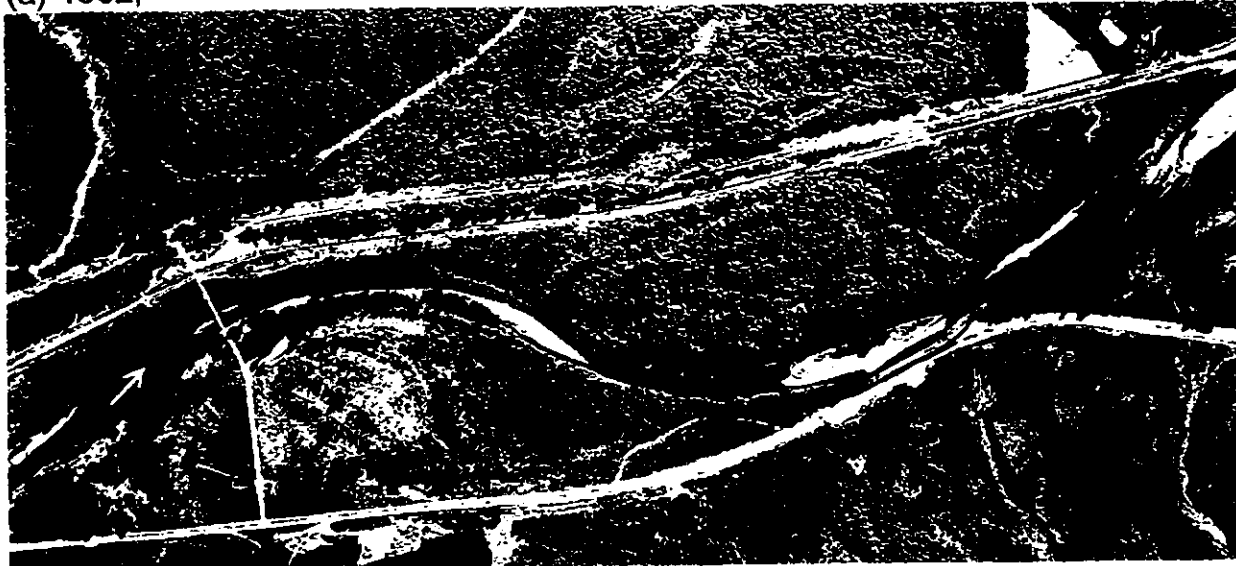
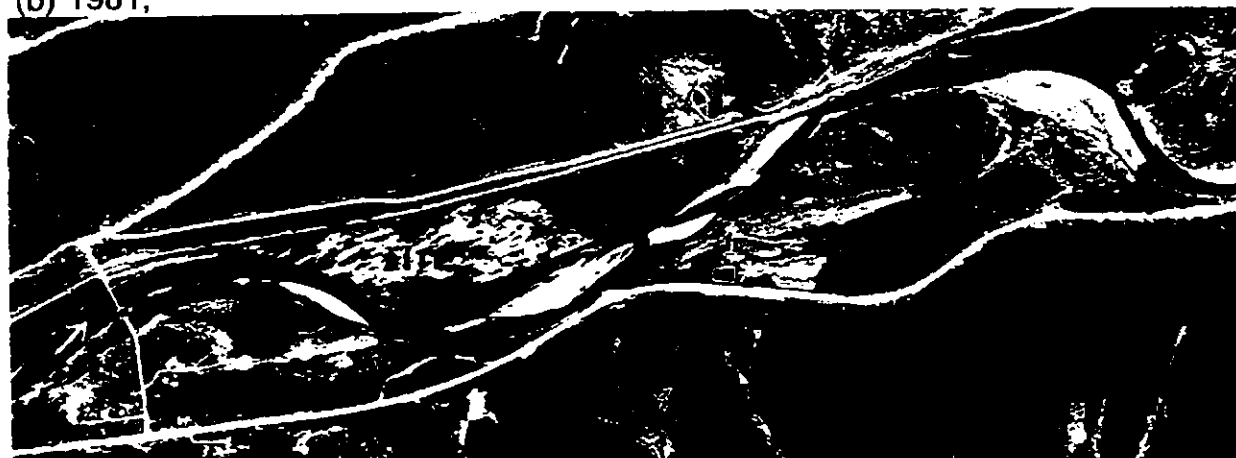
Figure 18. Elk River channel migration at $49^{\circ} 23' N$ $115^{\circ} 01' W$ from 1962 to 1994 leading to the merging of the island to the mainland. The images are a scale ranging approximately 1:15,000 to 1:20,000.

Substantial deposition and meandering occurred at Site 2 following the major 1995 flood. Figure 18a shows the meander lobe in 1962 with a small open bar shaded by mature cottonwoods and an island close to the opposite bank (circled). By 1981 the back of the meander lobe had been cleared, but a buffer strip of cottonwoods was left along the river (Figure 18b). The island across from the site had become connected to the left bank and large deposits existed (circled). By 1994, the whole meander lobe had been cleared, leaving a single row of cottonwoods along the edge (Figure 18c). The barren areas of 1981 (circled) had been colonized by the same types of vegetation found along the fringe that was left: black cottonwood, willow, red-osier dogwood, Columbia hawthorn, and a variety of grasses, wildflowers and sedges. A small bar occurred at the middle of the meander lobe and was chosen as Site 2 (Figure 18c arrow).

At Site 2, the small bar present in 1981 (Figure 18b), was enlarged by 1994 (Figure 18c arrow) and Site 2 continued to enlarge through 1997. Three

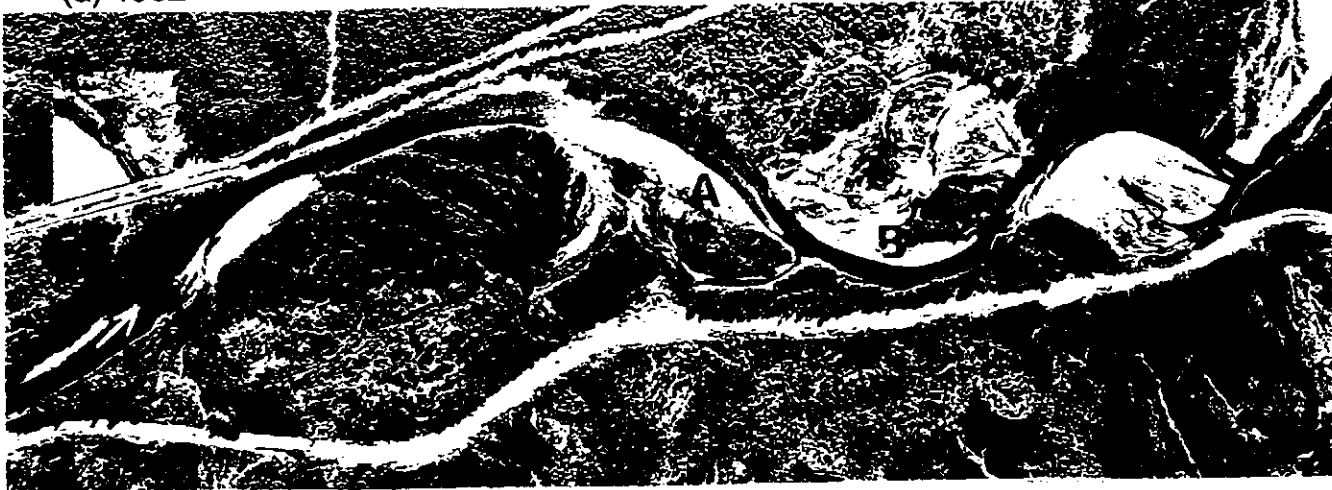
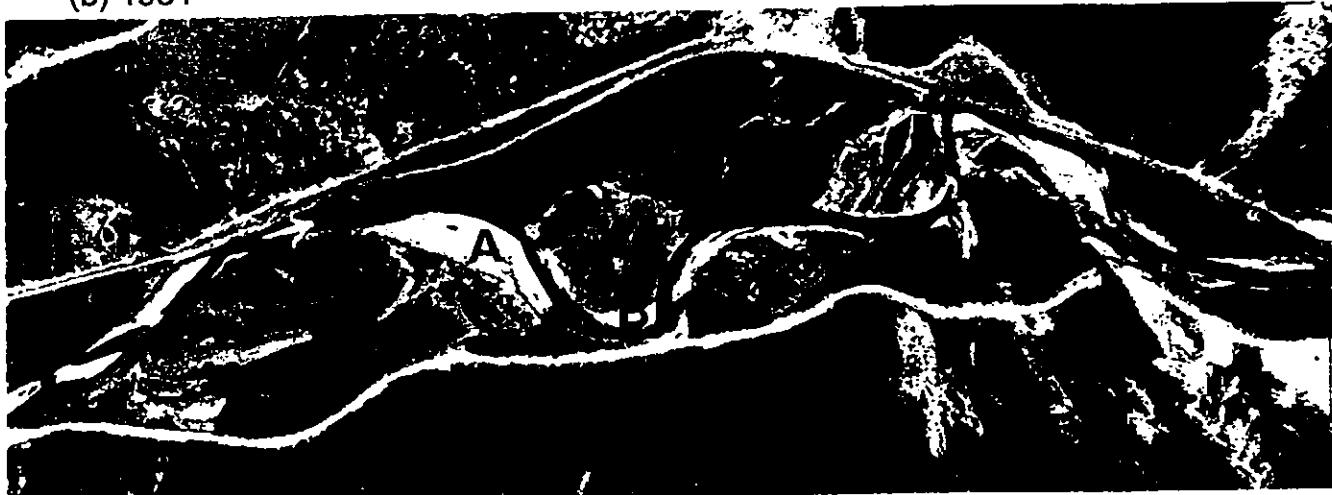
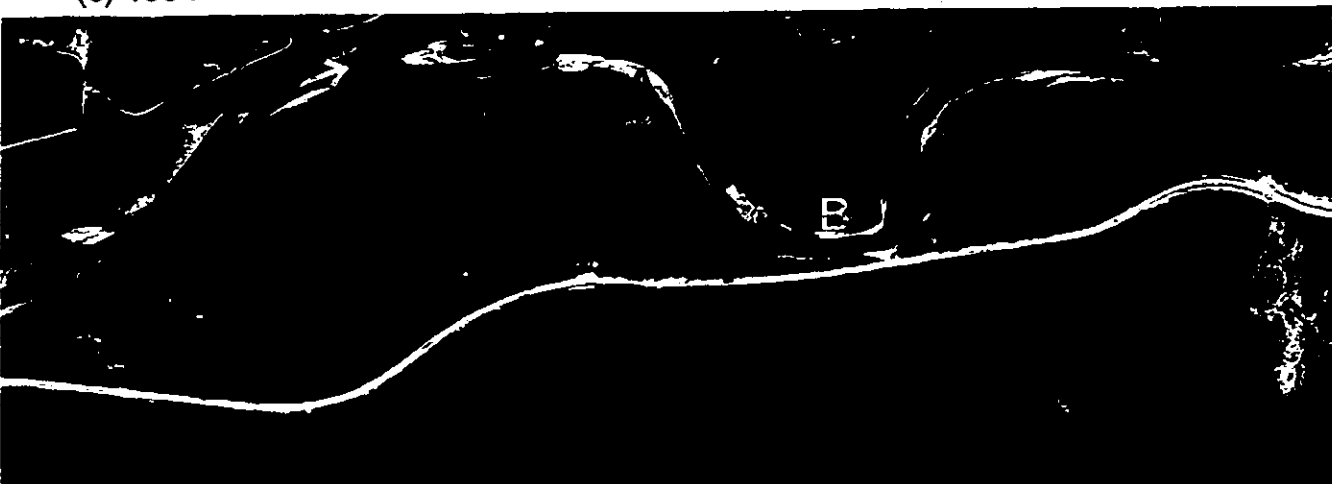
Figure 20. Elk River channel migration at $49^{\circ} 21' N$ $115^{\circ} 00' W$ (Site 3 [A]) from 1962 to 1994 causing change in sites labeled A and B and images are a scale ranging approximately 1:15,000 to 1:20,000,

Site 3 involved a newly formed bar resulting from the scouring away of vegetation and the deposition of fines, and cobble, resulting in a barren, cobble site more than 100 m long. The 1962 air-photo (Figure 20a) shows Site 3 with the freshly deposited bar flanked by vegetation, probably consisting of willow and juvenile cottonwoods. By 1981, the bar had progressed towards the opposite bank. Erosion had carved the inside edge to form a sharp 'S' bend in the river (Figure 20b). By 1994, the point bar had expanded through deposition and cottonwoods had colonized the meander lobe (Figure 20c). When the transect

The changes that the Elk River experienced from 1962 to 1994 at and near Site 3 can easily be seen by overlaying the 1962 river channel with the 1994 channel (Figure 21). Site 3 (A) and the migration of the meander lobe, is also visible by 1994. As well as the change in meander lobe A, meander lobe B had changed shape considerably (Figure 21). The channel pattern along this whole stretch had changed substantially. The arrows mark major changes but very little of the river channel is unchanged from 1962 to 1994 (Figure 21). Site 3 in 1996 is shown in Figure 22 with transect lines drawn in at the approximate positions. The average length of these transects was 100 m. Following the peak flow of 1997, the Elk River had eroded a small channel through the meander lobe leaving part of the outside portion as a mid-channel bar (Figure 22b). On the opposite side of the river, which previously (1996) had an eroding bank (Figure 22a), was a point bar in 1997 (Figure 23a). The inside edge of Site 3 was greatly reduced, leaving transect 0651, which was previously well in from the edge, at the eroding edge of the meander lobe (Figure 23b). The previously 100 m long cobble bar was thus reduced to less than 30 m in length.

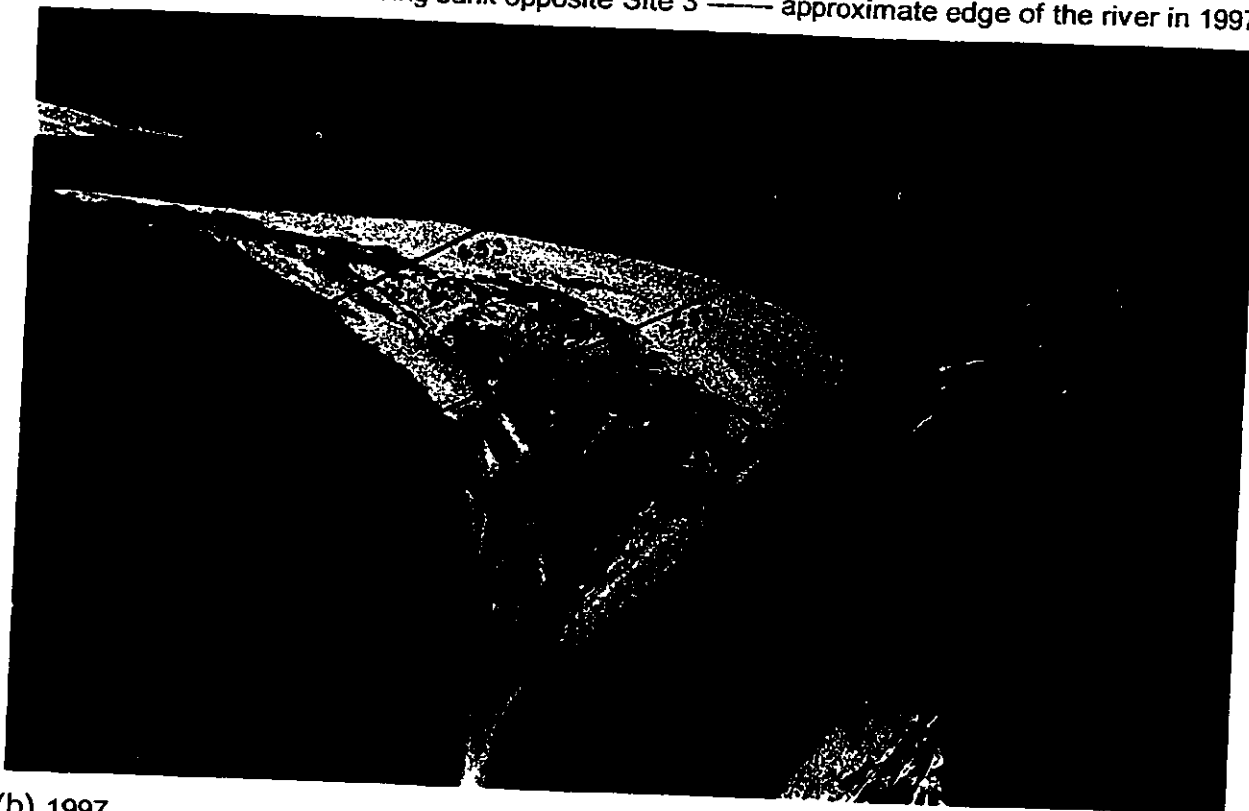
(a) 1996

A – eroding bank opposite Site 3 ——— approximate edge of the river in 1997

Figure 22. Site 3 ($49^{\circ} 21' N$ $115^{\circ} 00' W$) along the Elk River (a) Aug 3, 1996 with approximate positions of transects 651, 652, 653 and approximate new channel in 1997 marked, (b) Site 3 (X) in September 1997.

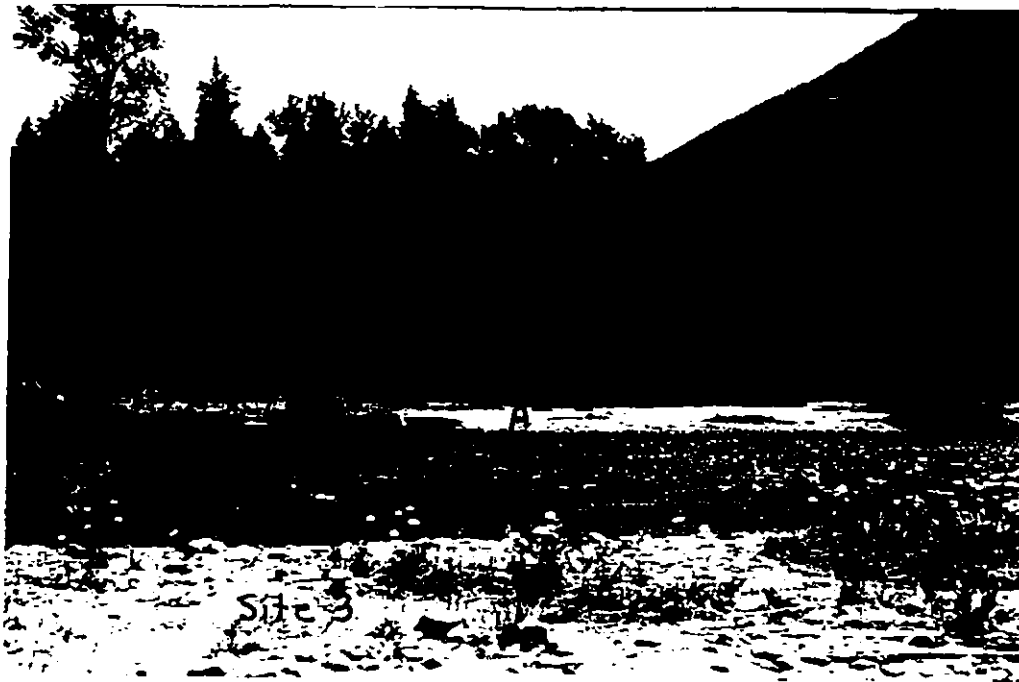
Figure 23. Changes that occurred at and near Site 3 ($49^{\circ} 21' N$ $115^{\circ} 00' W$) along the Elk River 1997. (a) The previously eroding bank across from Site 3, transect 0653 became a new point bar A. (b) The new channel which reduced the size of Site 3, transect 0651 is now on the eroding edge of the meander lobe, taken July 18, 1997.

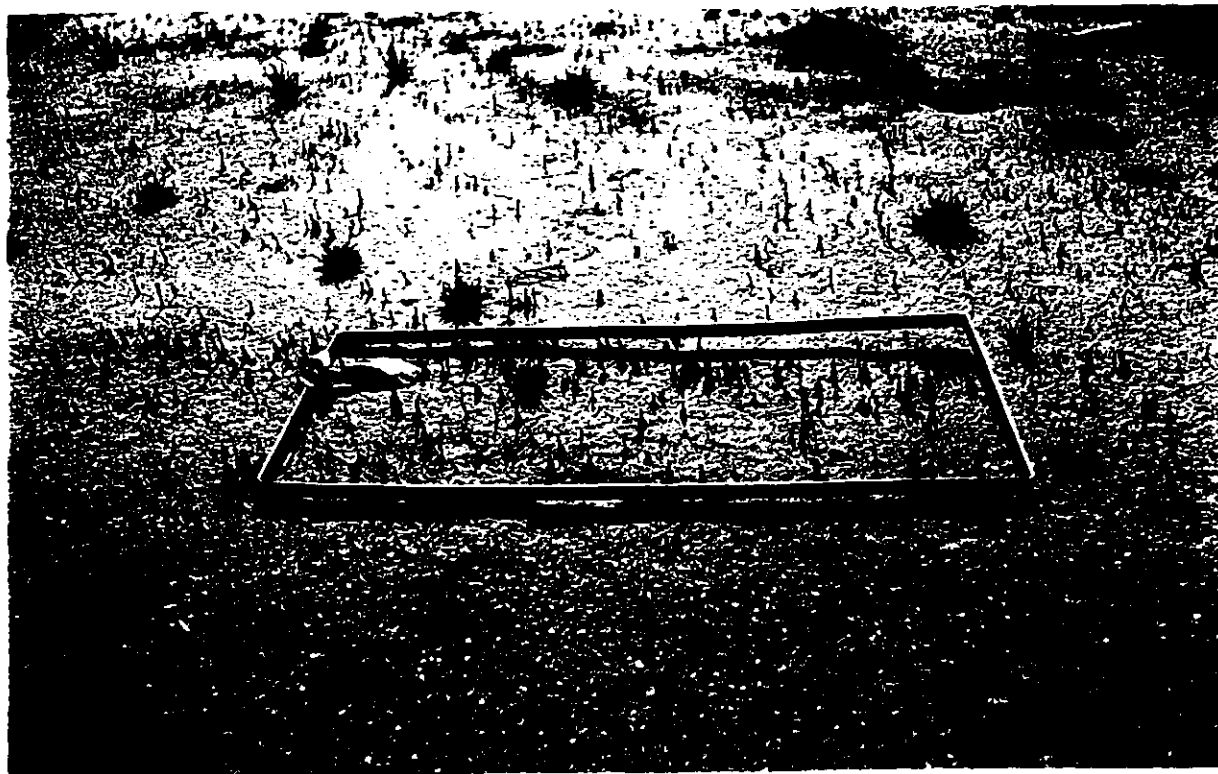
Figure 33. A 0.1 m^2 (20 X 50 cm) quadrat with 1997 cottonwood seedlings from Site 1 that had died from drought in 1997.

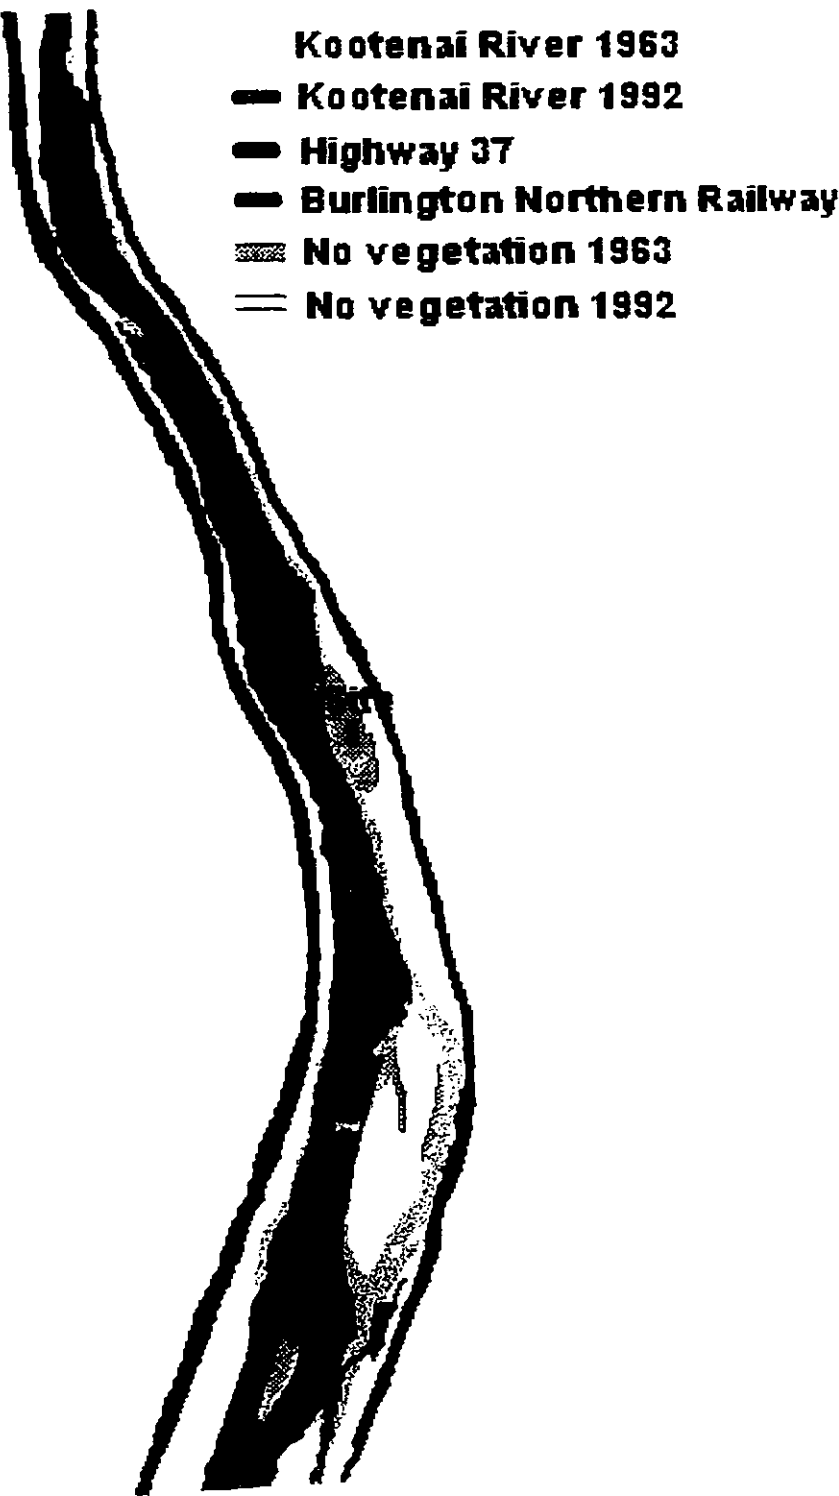
Figure 63. The Lower Kootenai River channel in 1963 with an overlay of the channel in 1992 (Site 1 at 48° 21' N 115° 22' W).

The comparison of the 1963 air-photos to the 1992 air-photos of the same study sites for the Lower Kootenai River reveals a different pattern following the completion of the Libby Dam in 1972. The three study site areas show a narrowing of the river which involved mid-channel bars and islands becoming attached to meander lobes, and a lack of active meandering (Figures 63, 64, 65). There was a ten year period involved in these air-photo comparisons prior to regulation but changes that might have occurred during this interval had apparently been eliminated with the subsequent narrowing of the channel. The 1992 air-photos were taken on June 21 and 22, and July 17, for Sites 1, 2, and 3, respectively, with similar discharges of $115 \text{ m}^3/\text{s}$ for the three dates. Even with this low discharge, only very small barren areas were exposed at the three study sites in June and July, 1992 during cottonwood seed release.

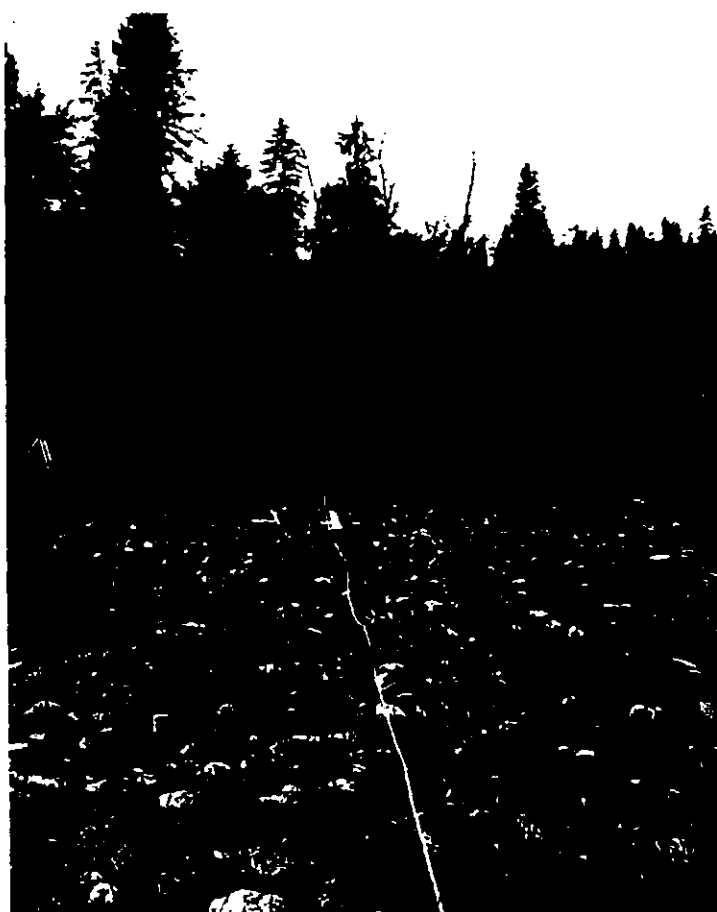
Figure 66. Site 1 along the Upper Kootenay River ($49^{\circ} 28' \text{ N } 115^{\circ} 30' \text{ W}$) (a) had a deep sandy substrate point bar compared to (b) Site 3 along the Lower Kootenai River ($48^{\circ} 26' \text{ N } 115^{\circ} 50' \text{ W}$) which had coarse cobble substrate.

The sites along the Lower Kootenai River possessed a striking difference in the surface substrate particle size relative to the free flowing Upper Kootenay reach. The Upper Kootenay River had fine substrate (sand and silt) bares with no exposed cobble or rocky sites along the entire study reach. The Lower Kootenai had only cobble sites with no fine substrate bars observed from the Libby Dam to Troy Montana (Figure 66).

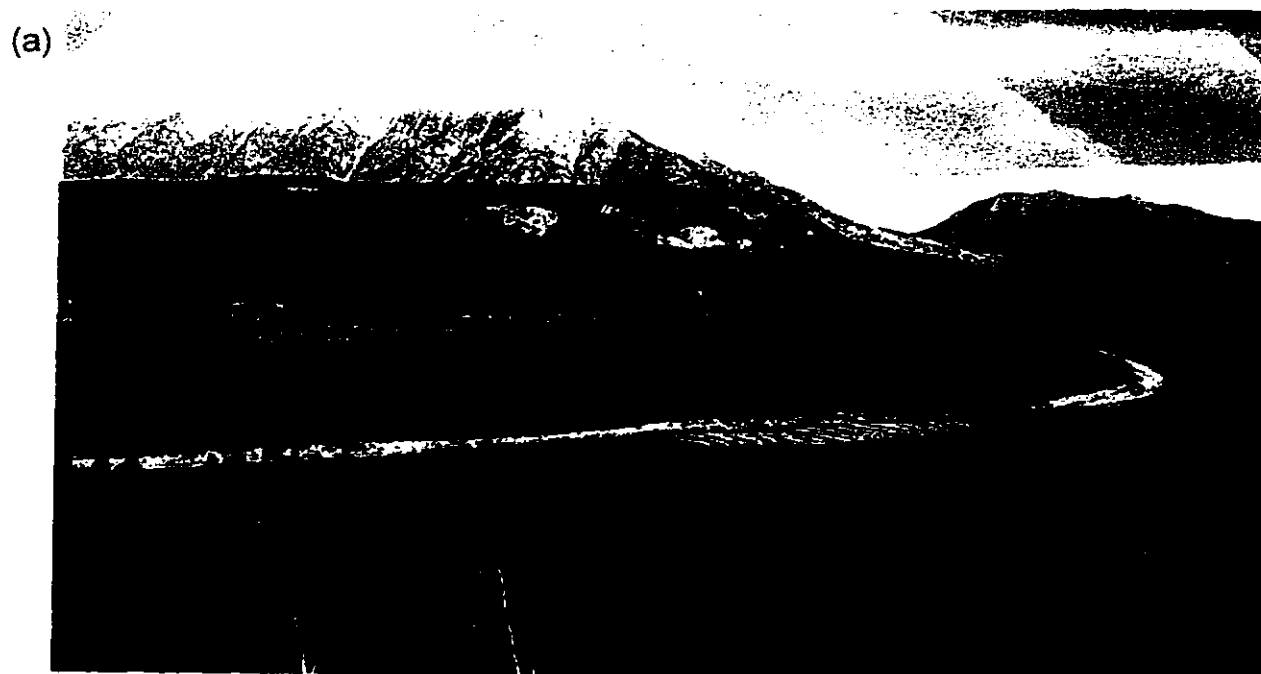
M – Mature black cottonwoods J – Juvenile cottonwoods S – Seedling recruitment sites

The Lower Kootenai sites had mature cottonwood trees and abundant seed release occurred in both years of the study (Figure 79). However, the Lower Kootenai Sites did not have the full range of age (size) classes of cottonwoods found in healthy riparian populations. The Lower Kootenai had a narrow band of mature trees with the band often being only a single tree wide with or without shrubs and low vegetation and especially grass to the river's edge. No bands of juvenile cottonwoods occurred between the mature trees and the recruitment zone and no cottonwood or willow seedling were observed along the stream edge (Figure 80).

In contrast, the Upper Kootenay River had mature trees furthest away from the river, with ages from 40 to 100+ years for the trees sampled; juveniles in front of the mature trees with ages decreasing from 30 to 5 years of age, and seedlings along the non-vegetated zones near the river's edge (Figure 80).

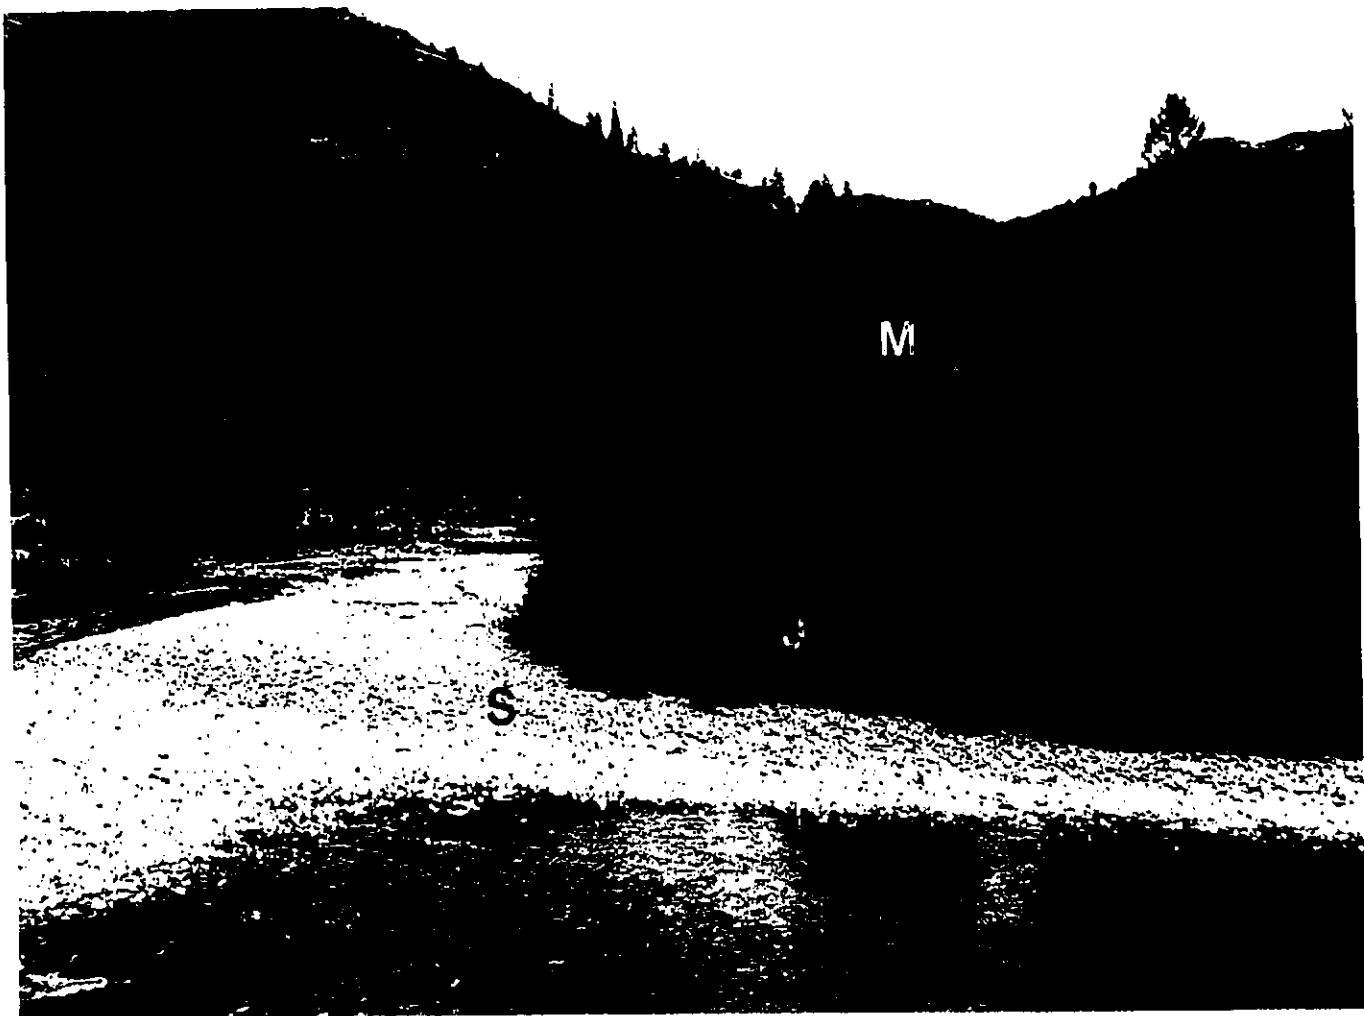
Figure 83 The black cottonwood population structure along the Fisher River upstream of Site 2 ($48^{\circ} 19' N$ $115^{\circ} 18' W$).

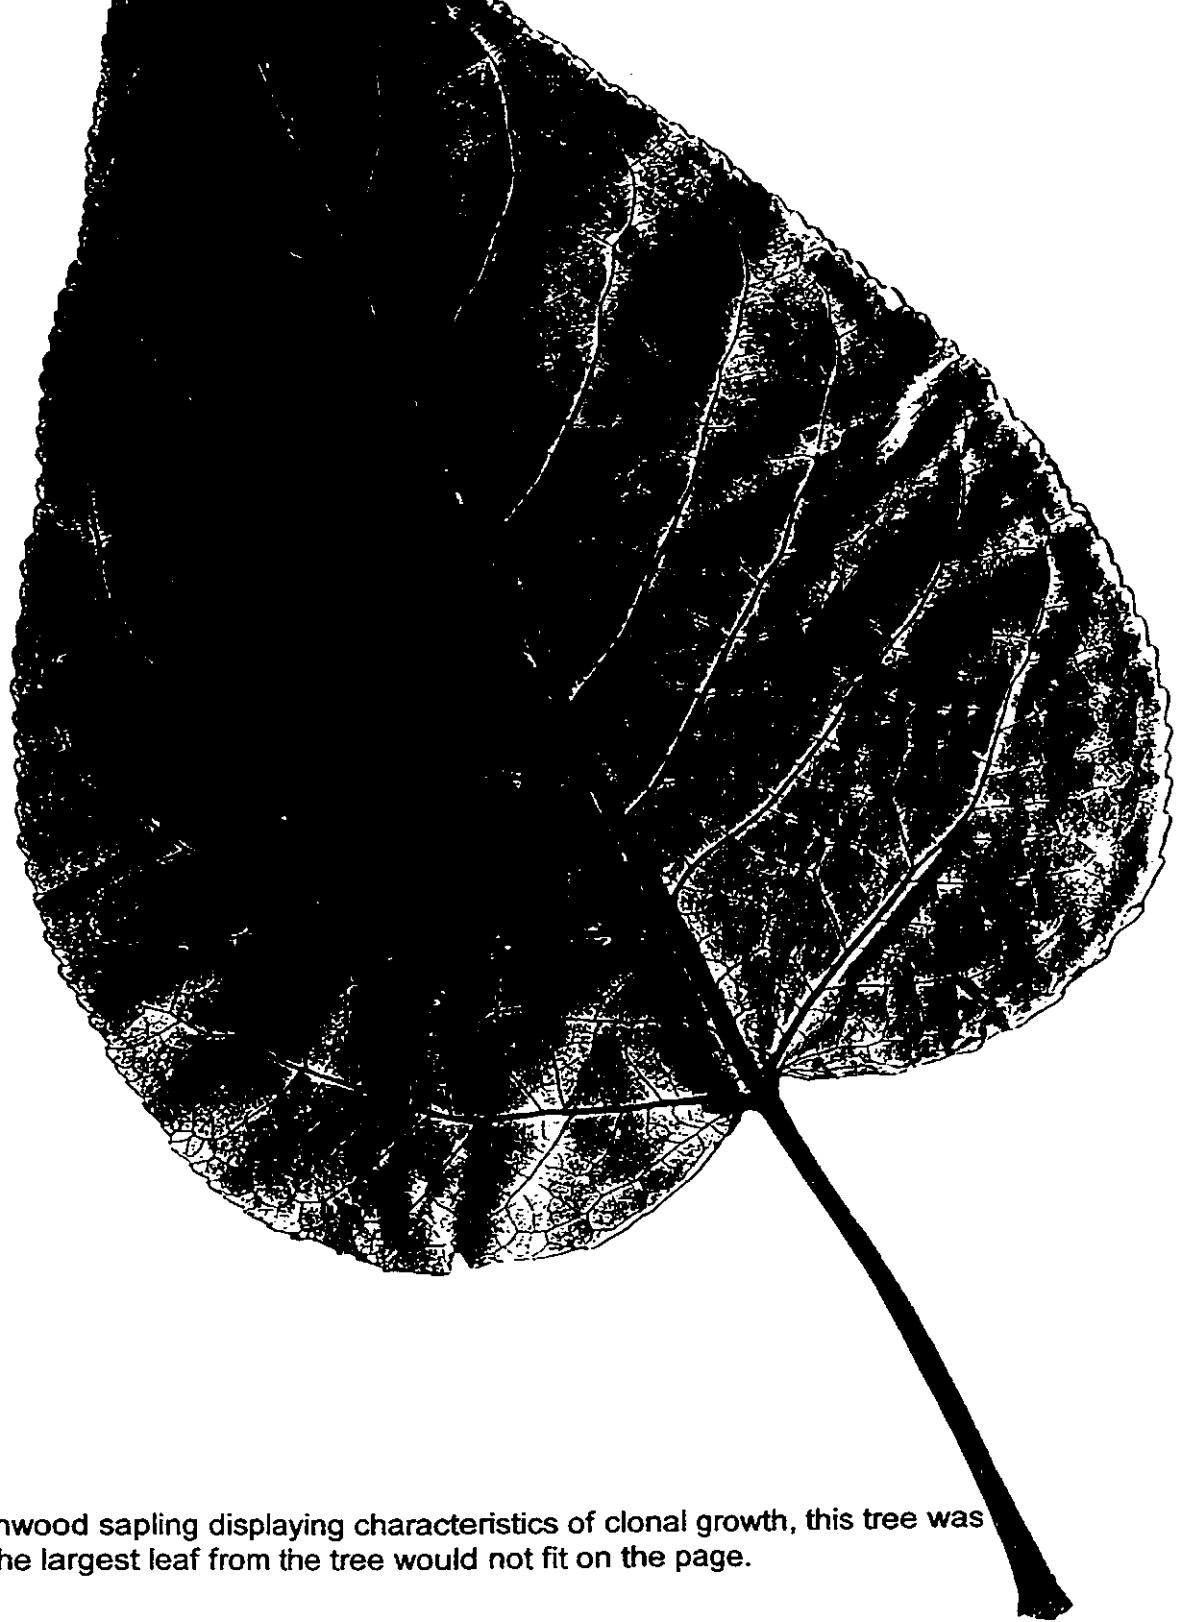
A leaf off a cottonwood sapling displaying characteristics of clonal growth, this tree was 6 years old and the largest leaf from the tree would not fit on the page.
